Analysis of the Thermal Stress and Strain on Arrigo Fiammingo's Artistic Window in the Cathedral of Perugia

Cinzia Buratti

Department of Industrial Engineering,
University of Perugia, Via G. Duranti 1-A/4,
06125 Perugia, Italy
e-mail: cburatti@unipg.it

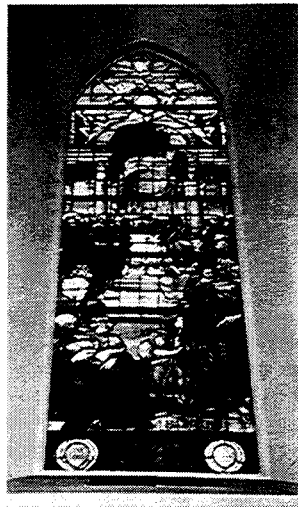
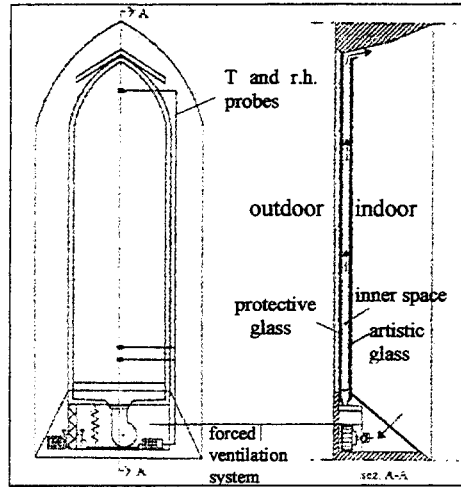
Fig. 1 Arrigo Fiammingo's window in the Cathedral of Perugia in its current state, with forced ventilation system in the space between artistic and protective glass

Arrigo Fiammingo's window is a window with one panel with maximum dimensions of 1.8×7 m (surface area: about 11 m²). The protective glass is placed on the external countersinking part of the window, at about 18 cm from the artistic window, which has about the same dimensions. Both artistic and protective windows have northerly exposure (see Fig. 1).

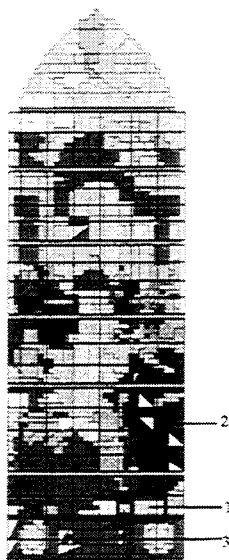
Fig. 2 Finite elements to analyze temperature, strain and stress distribution on Arrigo Fiammingo's glass; 1, 2, and 3 are the sections of the glass first examined

The lead pieces that surround the glass tesserae create discontinuities on the surface, because they have different thermal properties from the glass, so they behave differently when temperature varies. First, instead of analyzing the whole glass, three sections only were examined (Fig. 2). The first (1) has some colors that contains lead pieces; the second (2) and the third (3) are respectively blue and yellow (maximum and minimum absorption coefficient values), don't contain lead pieces and lead only surrounds the section.

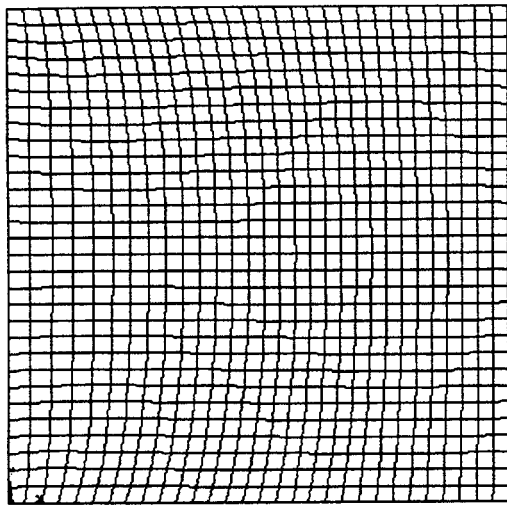
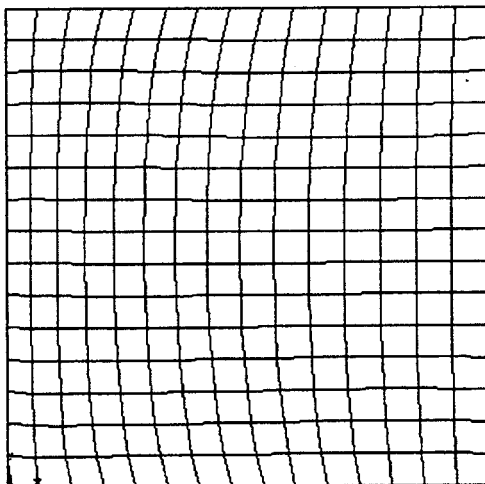
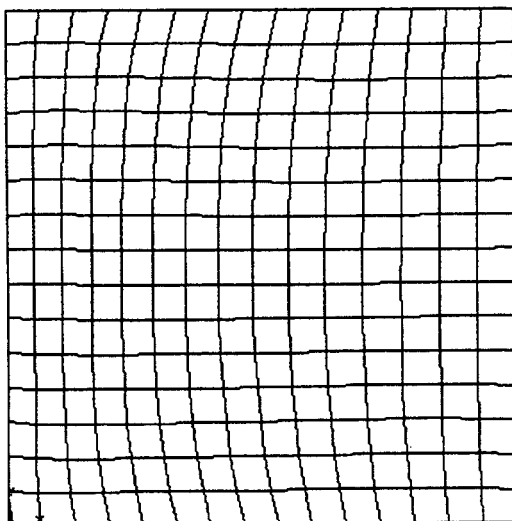
Fig. 6 Dilatation trends in glass sections (1), (2), (3)

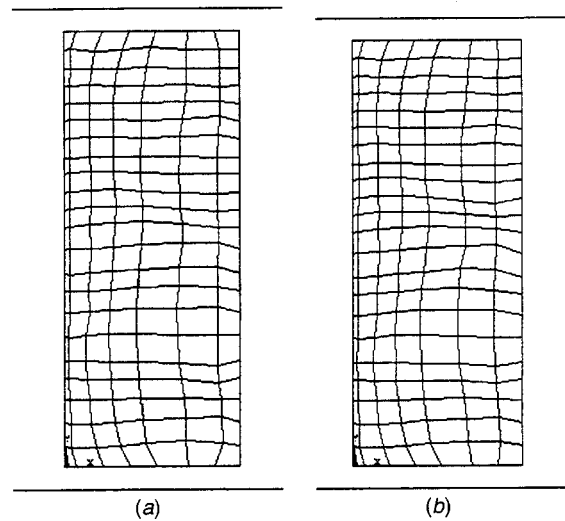
Fig. 7 Dilatation trends on the artistic glass subjected to direct and diffused sunlight (situation A) and to only diffused sunlight (situation B)

Figure 7(b), concerning dilatations in the situation B, shows that they depend only on the color of the tesserae which take on higher values in the darker colors. The maximum dilatation is about $0.042 \mu\text{m}$, remarkably below those of the previous case (the scale in Fig. 7(b) is about 2.5 times the one in Fig. 7(a)).

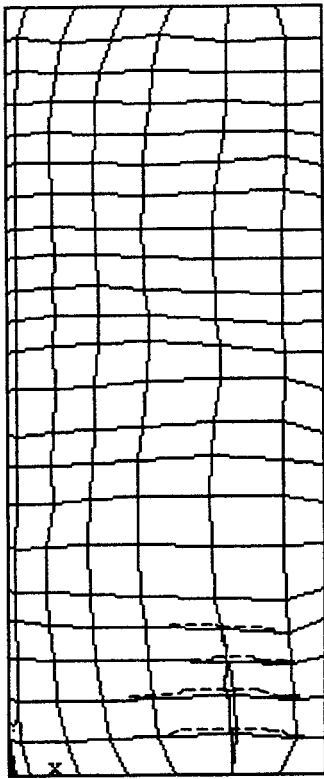
Fig. 8 Dilatation trend on the glass (situation A) when only lead is considered. the dashed lines show the dilatation differences of Fig. 7(a) (when only glass is considered).

A further verification about the lead influence was performed once the analysis was finished: a simulation was carried out considering the glass as if entirely made up of lead; the strain obtained was compared with those considering the window made up of only glass (see Fig. 8). The differences are negligible in all the portions of the glass sheet (about a few μm tenths in the worst conditions), thus confirming that the glass dilatation is not influenced by the surrounding lead.

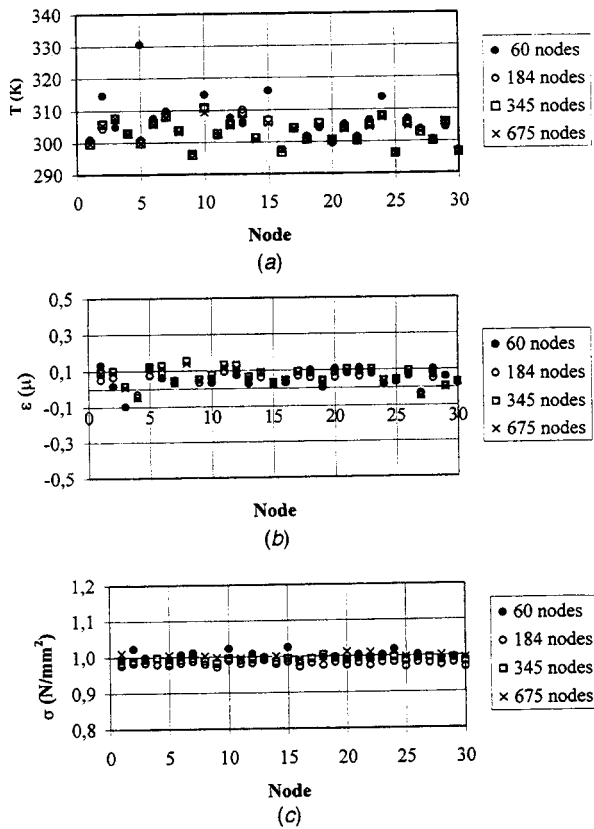
Fig. 10 Numerical accuracy: temperature (a), strain (b) and stress (c) values in 30 significant nodes, with different mesh refinements.

Results are shown in Fig. 10(a,b,c), where temperature, strain and stress values in the 30 grid points chosen are reported, for the different mesh refinements; the mean difference between mesh 1 and 2 is significant (temperature differences are about $\pm(0-30)^{\circ}\text{C}$, strain differences are about $\pm(0.05-0.08)\ \mu\text{m}$ and stress differences are about $\pm(0.02-0.04)\ \text{N/mm}^2$). The mean differences between mesh refinements 2 and 3 and mesh refinements 3 and 4 are of the same entity and are less significant; they could be considered as the numerical accuracy of the model. So the mean values of the numerical accuracy are

- about $\pm 0.4^{\circ}\text{C}$ for temperature calculations
- about $\pm 0.02\ \mu\text{m}$ for strain calculations
- about $\pm 0.01\ \text{N/mm}^2$ for stress calculations.

The mesh refinement no. 2 is therefore the one chosen for the simulation.

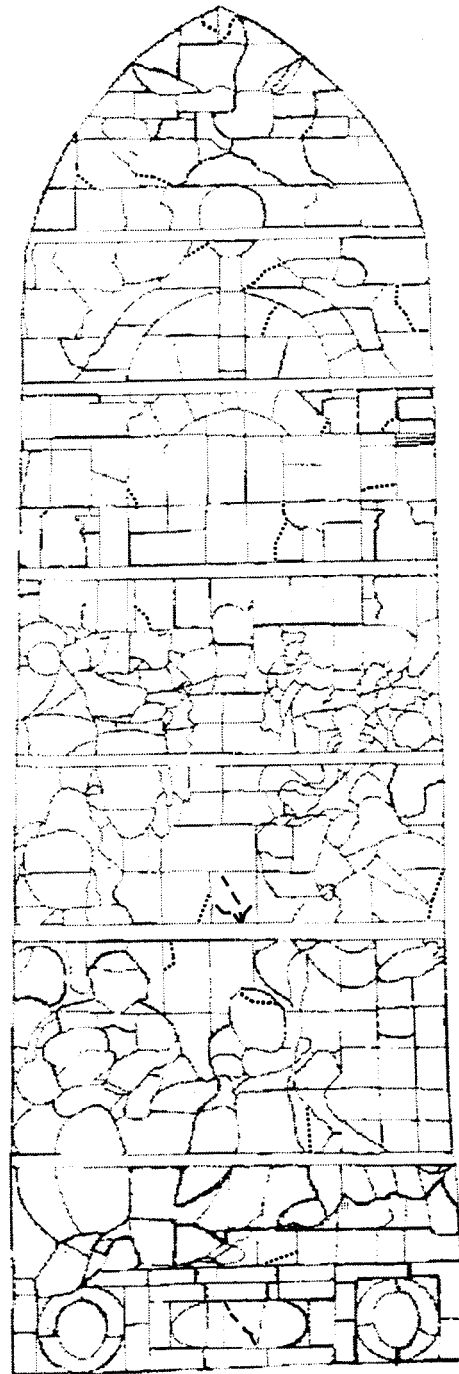
Fig. 11 Current lesions (dashed lines) and lesions repaired with added lead (dotted lines) during the 1998 restoration and before

Many interventions had been carried out during the 1989 restoration, when fissures were welded with lead. Strands of lead were inserted to repair and support the fragments of glass tesserae damaged throughout the years (the so-called *added lead*). Figure 11 indicates these interventions with dotted lines; dashed lines show the fissures now present on the glass. The actual fissures are in the area where the strain of the glass is highest (see Fig. 7). Therefore, even after restoration, the thermal stress could have caused the glass tesserae rupture, although the stress values are below the limits.

So in the present conditions there is a temperature, strain and stress distribution, which should not cause lesions on the surface of the artistic glass. But the investigation was conducted assuming that the glass is in perfect condition, without considering the deterioration or aging factors: these could decrease the mechanical and resistance characteristics of the glass tesserae. Other environmental factors, which can act alone or worse yet simultaneously, can speed up the process of deterioration (temperature and relative humidity of the air, air pollution, natural or artificial lighting conditions, etc.) [1,3]. This explains why some lesions on the glass were found in the area most subjected to stress and strain.

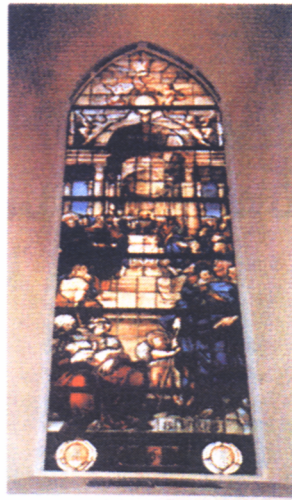
Fig. 1 Arrigo Fiammingo's window in the Cathedral of Perugia in its current state, with forced ventilation system in the space between artistic and protective glass

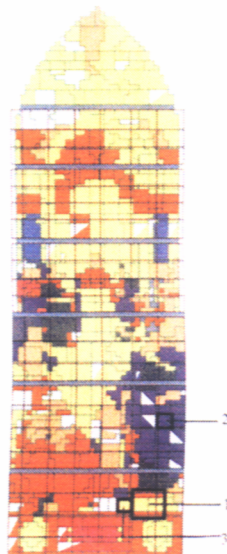
Fig. 2 Finite elements to analyze temperature, strain and stress distribution on Arrigo Fiammingo's glass: 1, 2, and 3 are the sections of the glass first examined

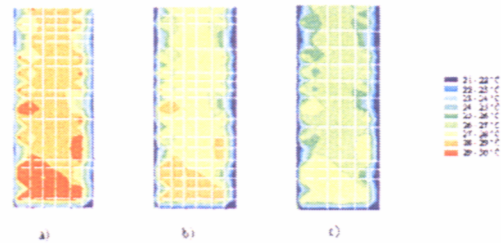
Fig. 4 Temperature distribution with only diffused sunlight (situation B): (a) without external protective glass; (b) with external protective glass and natural ventilation of the inner space; (c) with external protective glass and forced ventilation of the inner space.

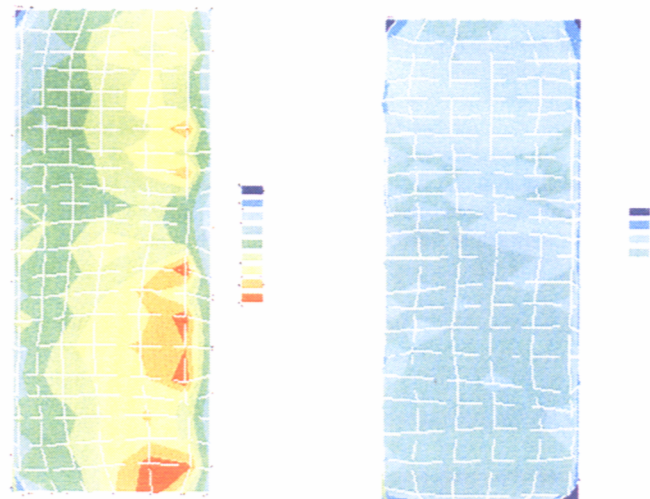
Fig. 9 Von Mises' stress trends on the glass in the situations (A) and (B), with protective glass and forced ventilation in the internal space.
